RI 9242

REPORT OF INVESTIGATIONS/1989

# Surface Fracture Development Over Longwall Panels in South-Central West Virginia

BUREAU OF MINES

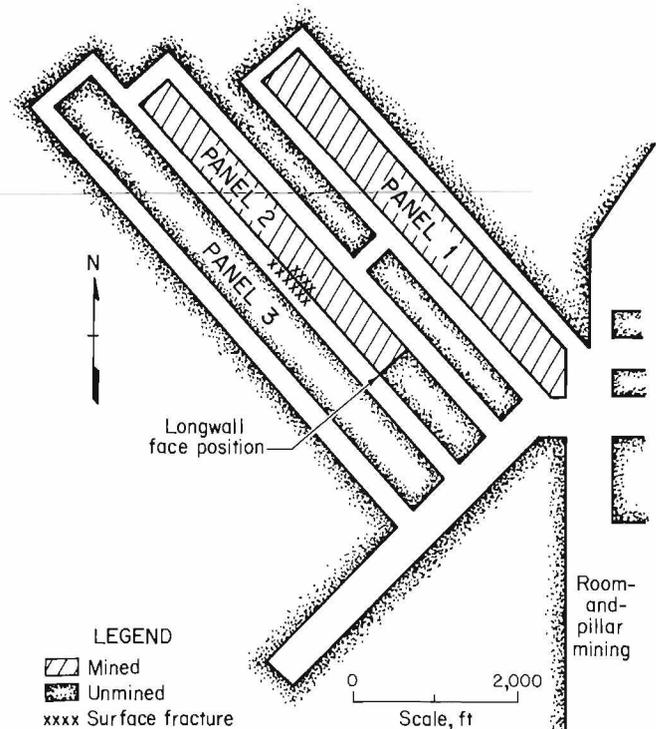
The study area at Mine A includes three adjacent longwall panels (fig. 3). The panels are oriented N 45° W, range from 400 to 600 ft wide, and 5,000 to 6,000 ft in length. Mining of these panels begins in the northwest and advances to the southeast. The two fractures that were investigated at this mine are situated over the headgate entries of longwall panel 2 (fig. 3). This panel was 500 ft wide and 5,400 ft long with four entry gate roads on either side. Overburden near the fractures ranged from 600 to 1,100 ft. Mining of this panel required 7 months. The monthly rate of mining for this panel was about 800 ft. One fracture was observed approximately 2 months before completion of the panel. This fracture was detected by the presence of a large linear bare spot in the snow-covered ground. At that time, the longwall panel working face was positioned about 1,500 ft southeast of the reported fracture (fig. 3). The second fracture was observed 3 months later, after the panel was completed.

Figure 3.—Location of surface fractures and longwall face position at Mine A.

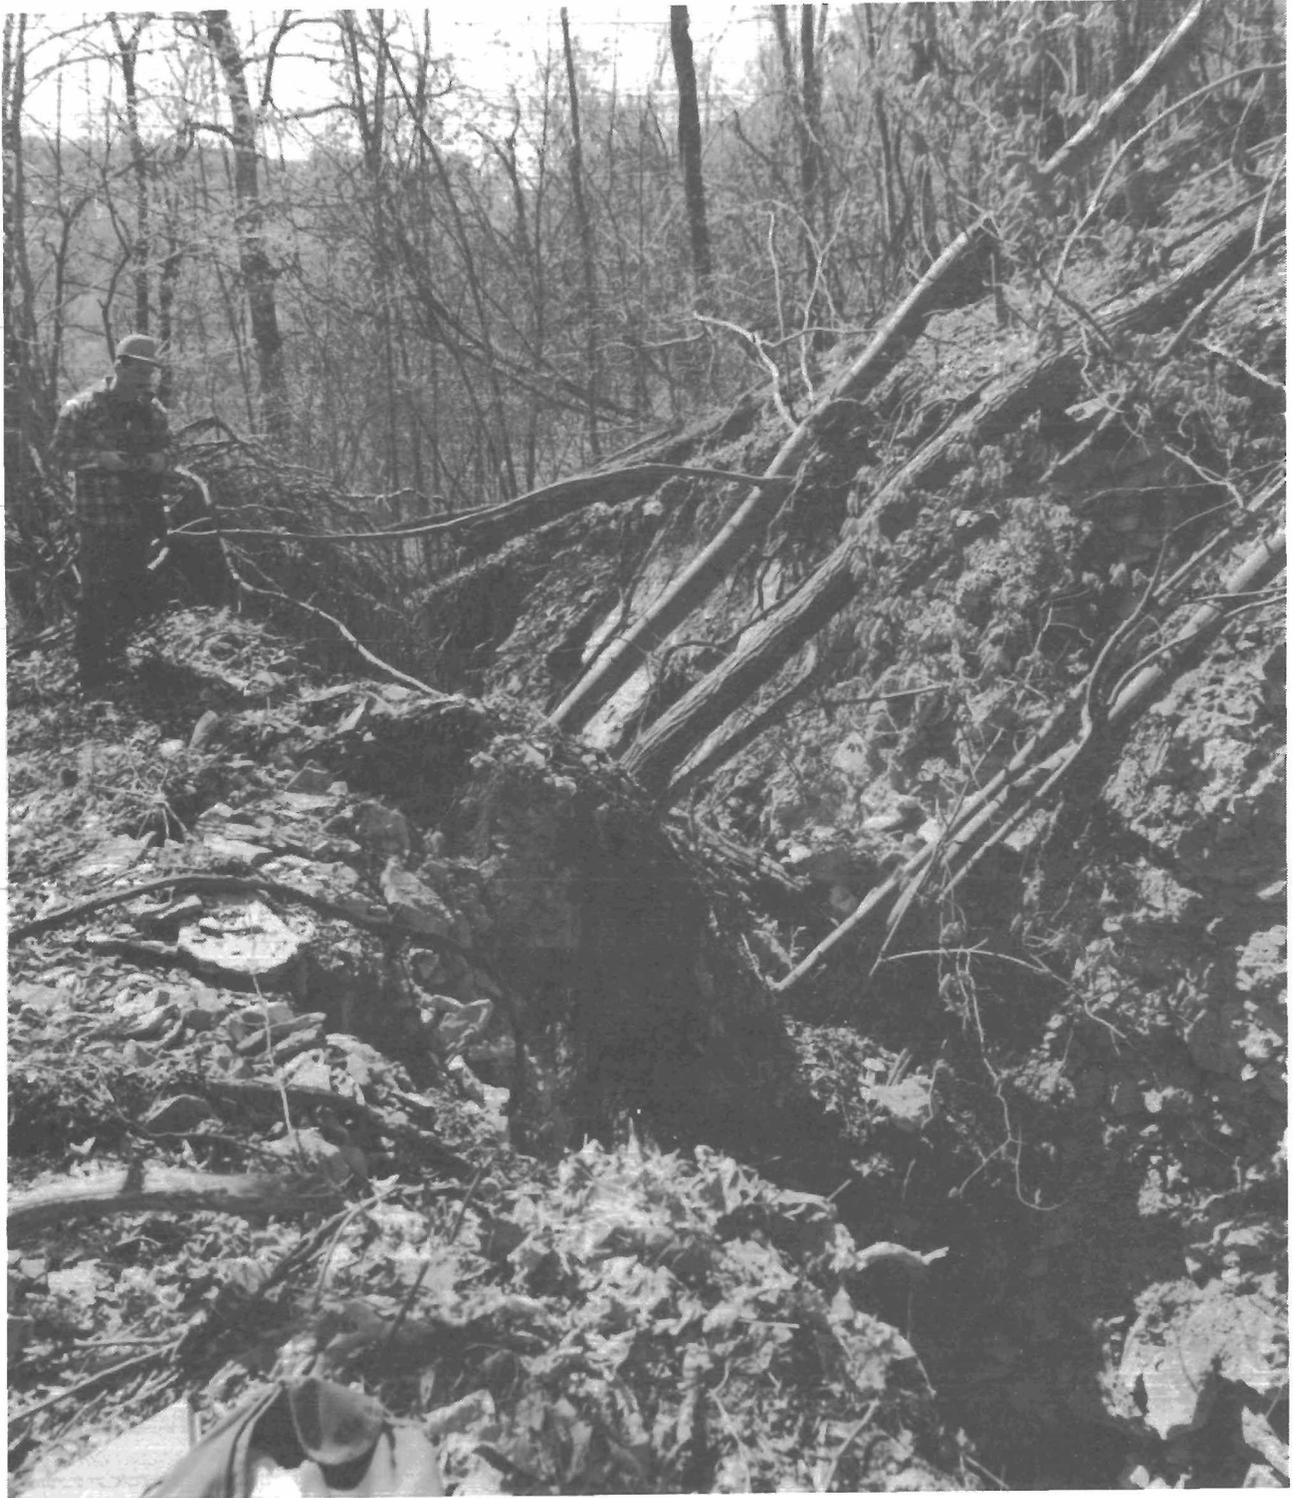
Field investigations revealed that the two fractures were continuous, parallel, and linear. One fracture measured 900 ft in length, and the other measured 450 ft (fig. 4). Orientation of the fractures varied from N 30° W to N 40° W. In cross section they were V-shaped. The width of the fractures, on the surface, ranged from a few inches at the ends to 25 ft towards the center. The fracture width appeared to narrow with increasing fracture depth. Fracture depth also varied from several inches to more than 50 ft into bedrock. A well-pronounced vertical fracture or joint plane was observed in the bedrock along the wider zone of the fractures (fig. 5). The fracture planes appear to curve toward the northeast about 30 ft below the surface.

Figure 4.-Largest fractures over Mine A.

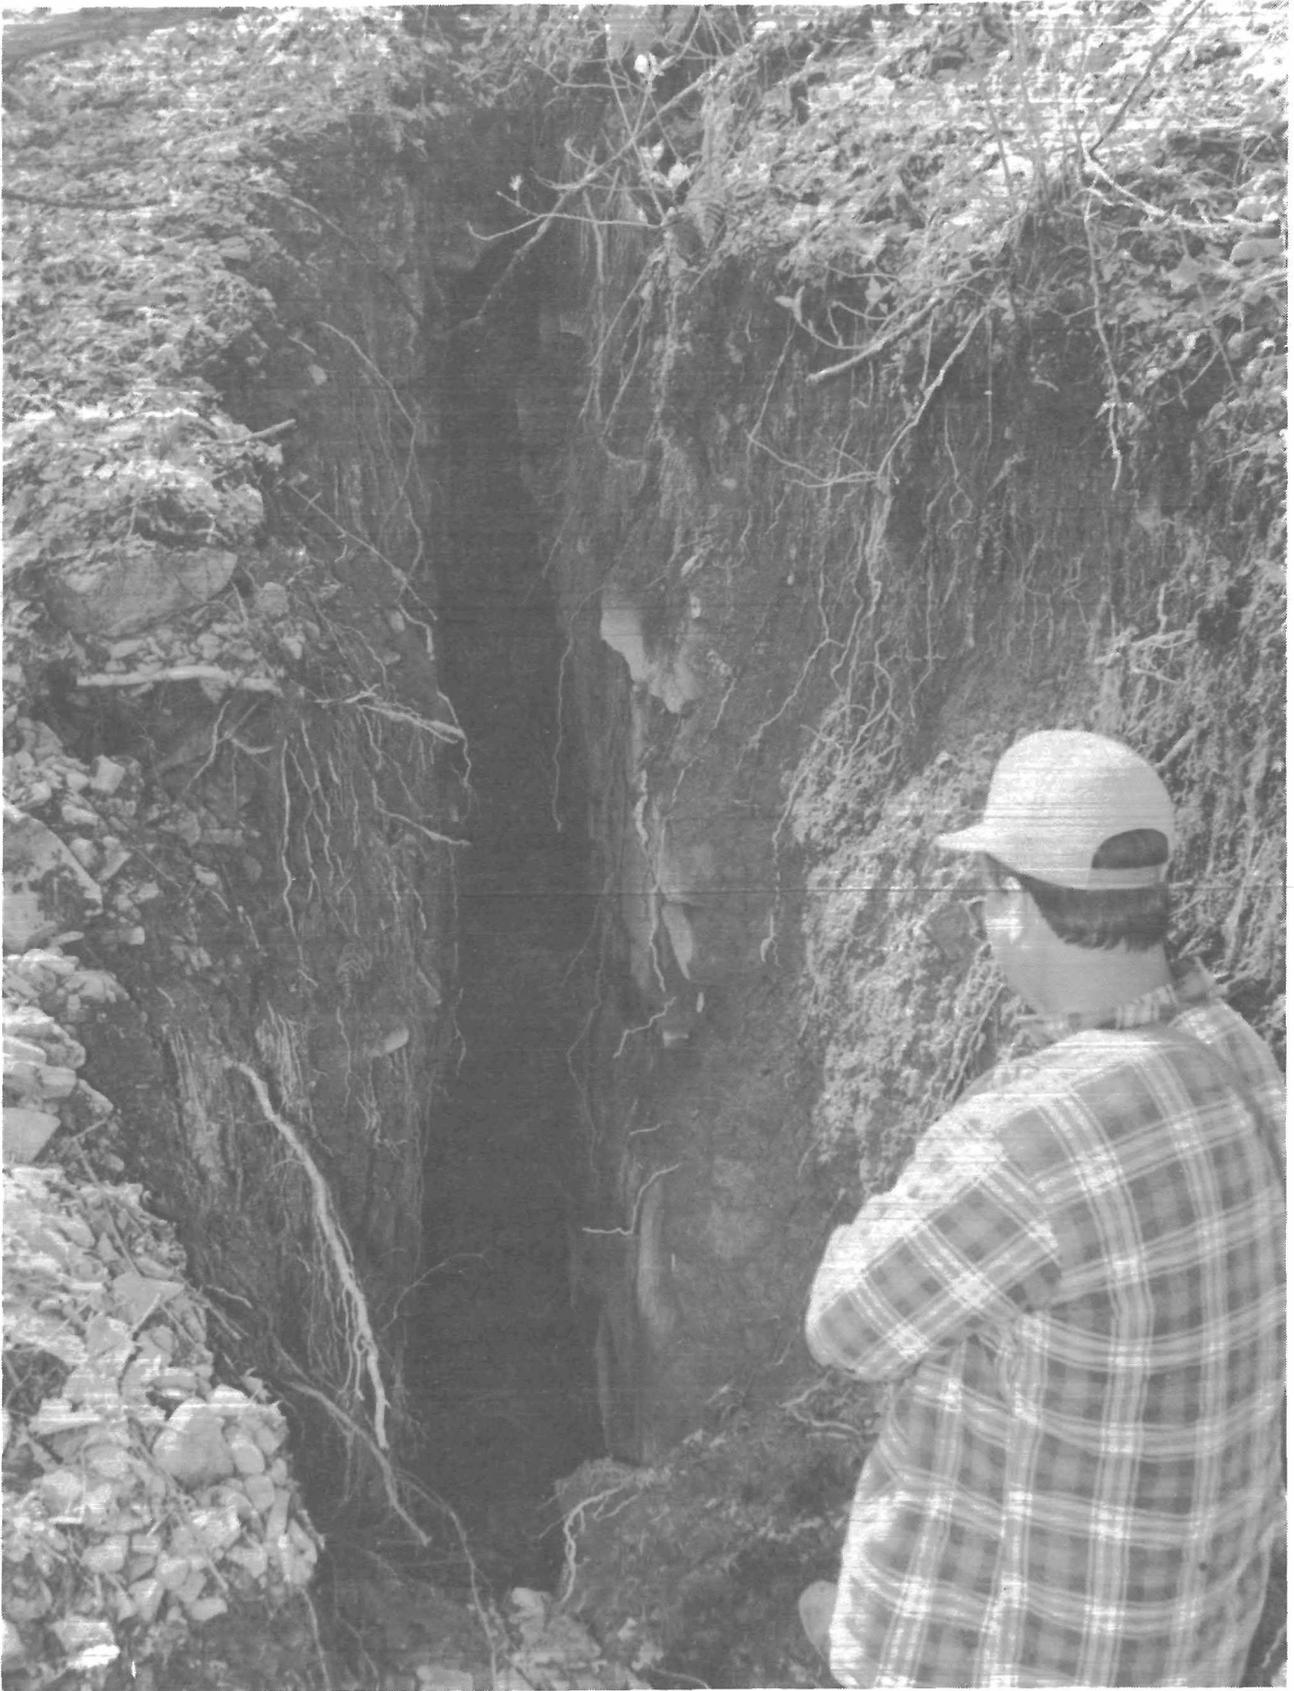
Figure 5.-Joint plane in open zone in fracture at Mine A.

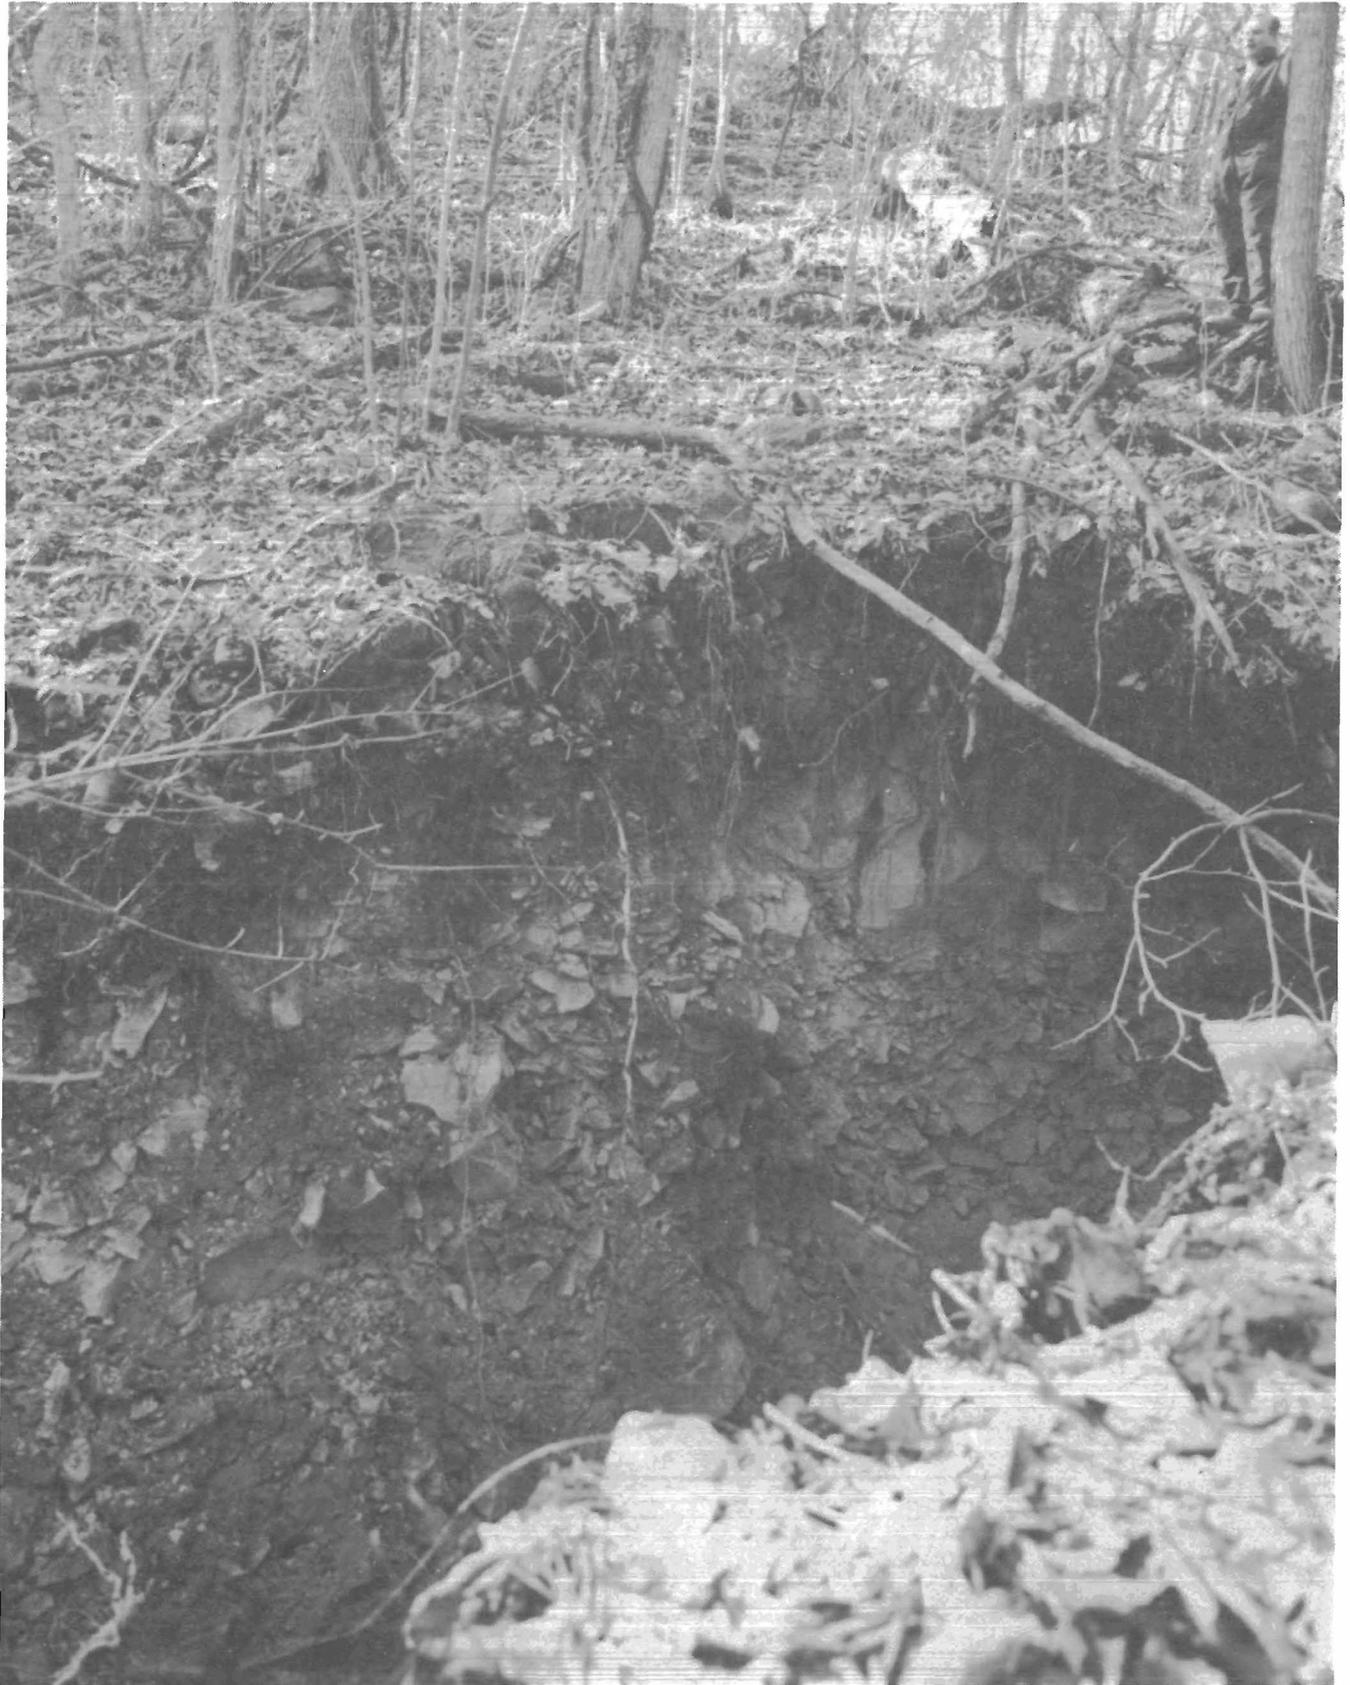
The stratigraphy viewed in the largest fracture exhibited unconsolidated surface material varying in thickness from 0 to 35 ft. This zone was composed of strip mine spoil deposits from previous hilltop strip mining operations (fig. 6). The uppermost rock unit was a 1- to 1.5-ft-thick coalbed. This coalbed overlies a claystone deposit about 2 ft thick. Under the claystone was a 3-ft-thick coalbed and then a massive sandstone, over 20 ft thick, as deep as

Figure 6.-Strip mine spoil in open zone along fracture at Mine A.

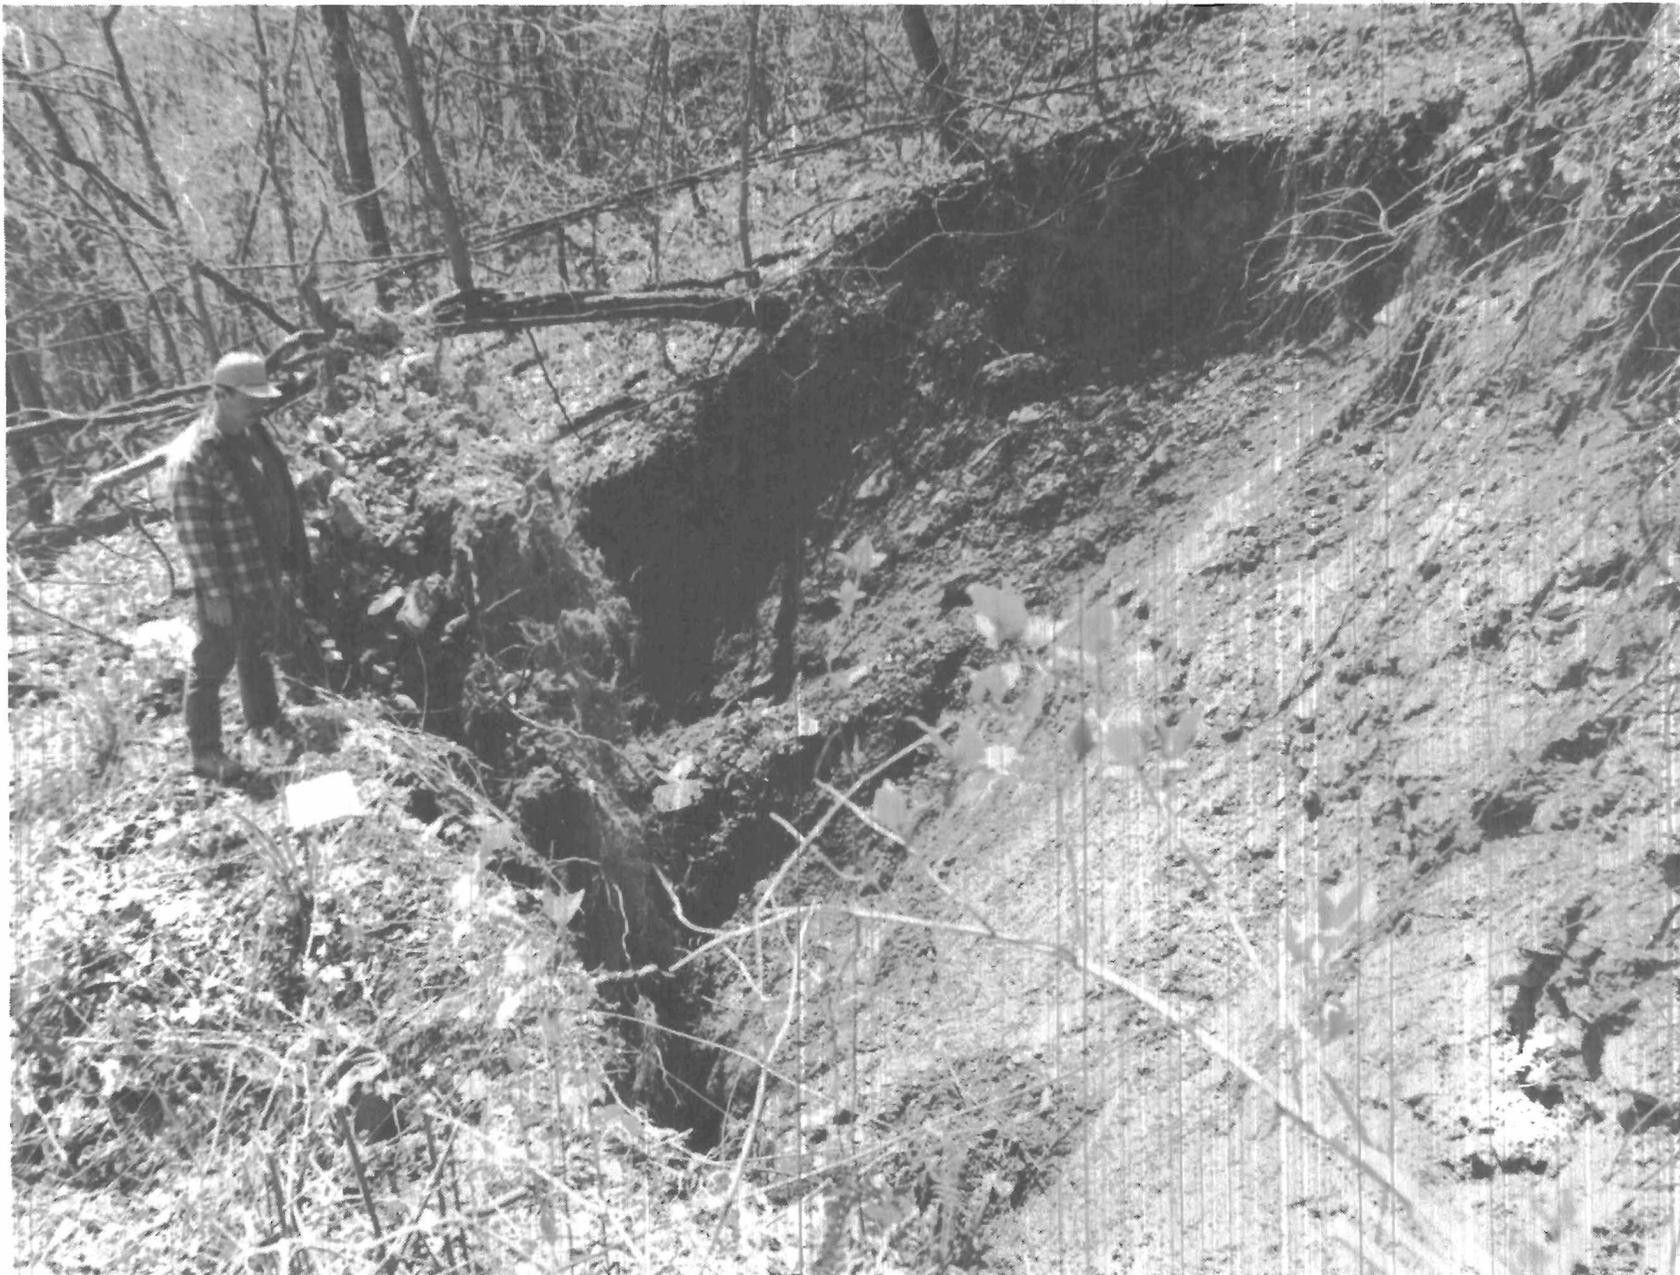
During the 4-month field investigations, the fracture characteristics changed somewhat. The first observed and largest fracture extended both in length and width. Fracture length increased approximately 200 ft (on both ends) during the first 2 months. Fracture width, which only widened at the surface, increased as much as 10 ft. This increase in width was due to the strip mine spoil eroding and collapsing into the fracture opening (fig. 7). Such erosion of the mine spoil and in-filling the open fracture void caused a general decrease in fracture depth. It is not known if the smaller fracture developed at the same time as the larger one. However, the characteristics of the smaller fracture also appear to have changed in a similar manner as the larger fracture. The fracture width at the surface was also eroding and collapsing into the void area.

Figure 7-Overburden eroding and washing into open fracture at Mine A.

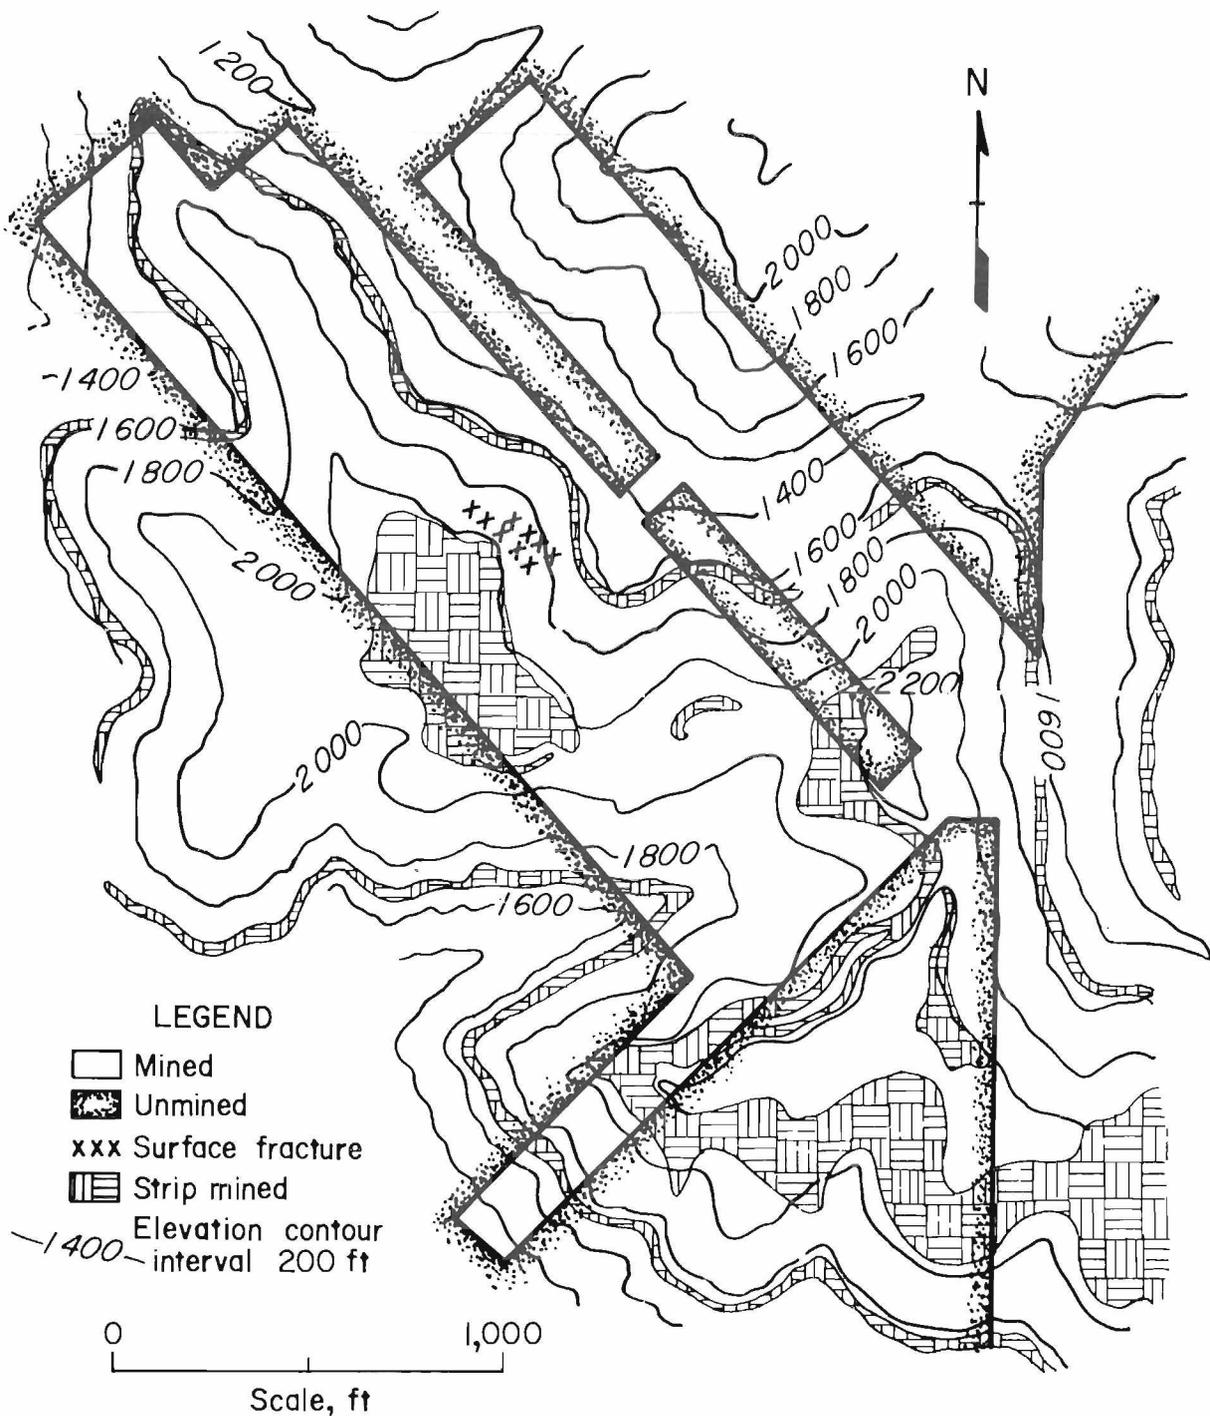
Both fractures are situated along a hillside closer to the top of the ridge than the valley bottom (fig. 8). The fracture trended subparallel to the valley and ridge. The largest fracture ranged in elevation from 1,860 to 2,040 ft, about 80 to 200 ft below the top of ridge. The smaller parallel fracture was about 80 ft below the larger fracture.

Hilltop and contour-auger strip mining was evident above and below the fractures (fig. 8). Both strip mining operations occurred before the development of the underlying longwall panels. The effects from the hilltop strip

Figure 8.—Topographic map with locations of fractures overlying Mine A.

The reason the fractures at Mine A are larger than the fractures at Mine B could be the effects of old strip mine workings located above and below the fractures at Mine A (fig. 8). Both strip mine operations disrupted the natural contouring of the original surface. The lower strip mine bench could have altered the natural stability of the slope before undermining occurred. The slope of the hillside is

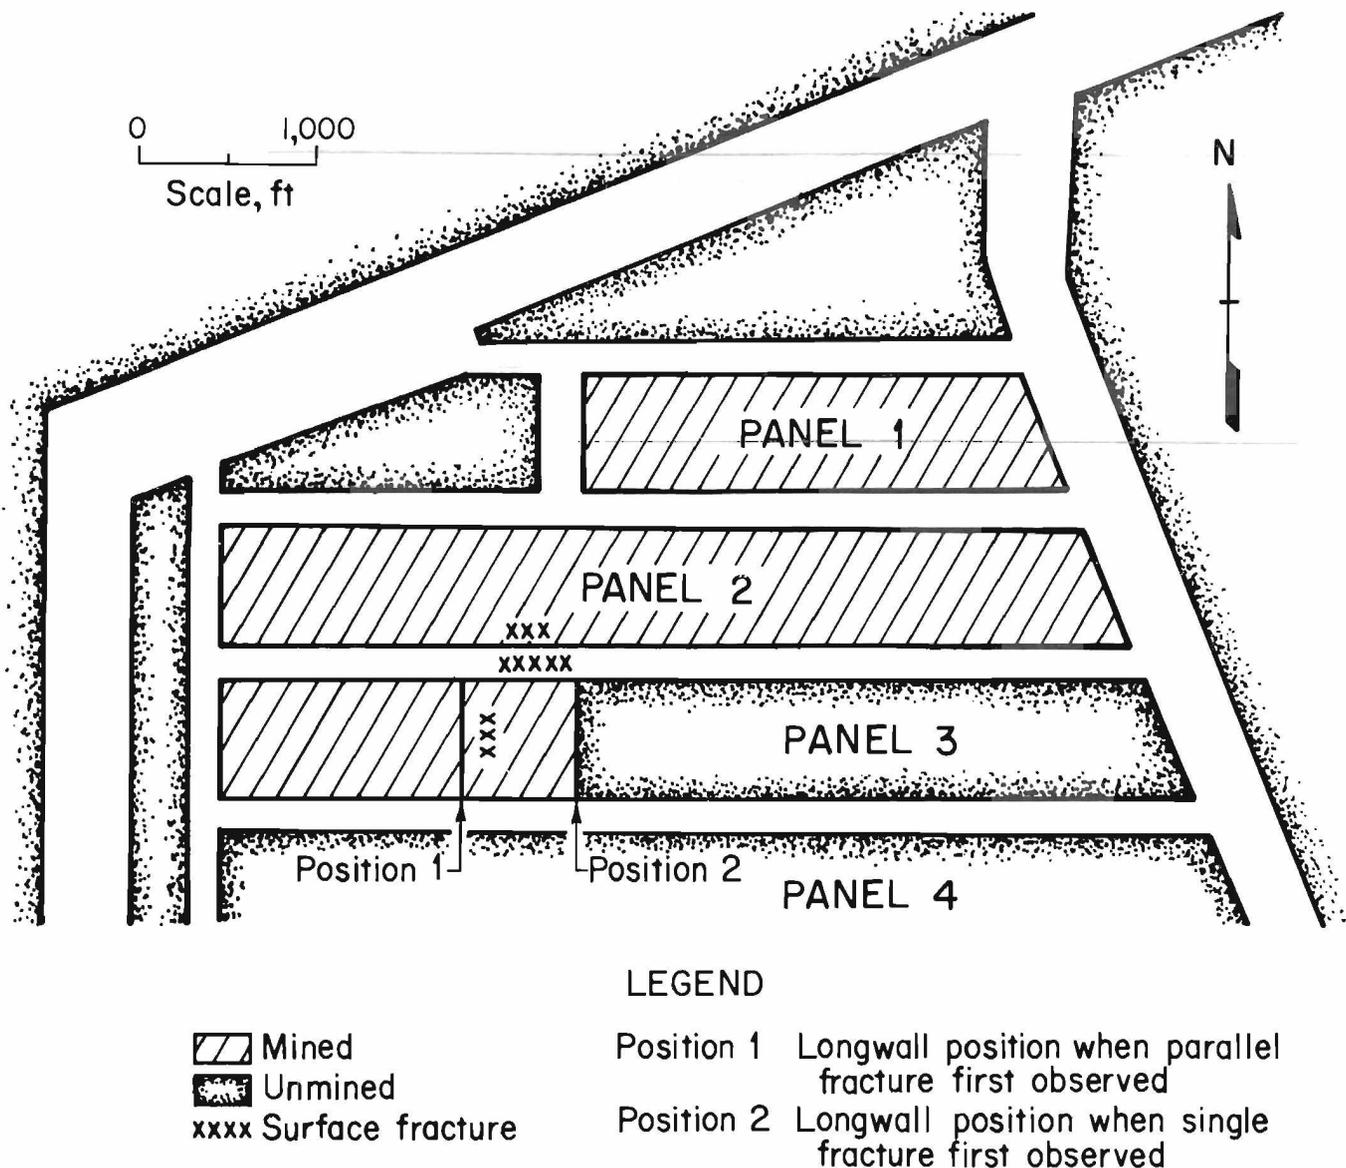
The study site at Mine B included a series of four adjacent longwall panels (fig. 9) orientated N 87° W. The panels were 650 ft wide and ranged from about 2,400 to 5,500 ft in length. Mining of the panels advanced from west to east. Three fractures were observed at Mine B; two were over the gate entries between panels 2 and 3,

The fractures at this mine, as at Mine A, were first observed by surveyors after snow accumulation. The two paralleling fractures, positioned over the gate entries, were first observed after panel 2 was completed. The working longwall face on panel 3 was positioned about 350 ft west of the two fractures (fig. 9). The single fracture overlying panel 3 was first observed when the longwall face was about 520 ft east of this fracture (fig. 9). Again as at Mine

Figure 9.—Location of surface fractures and longwall face positions at Mine B.

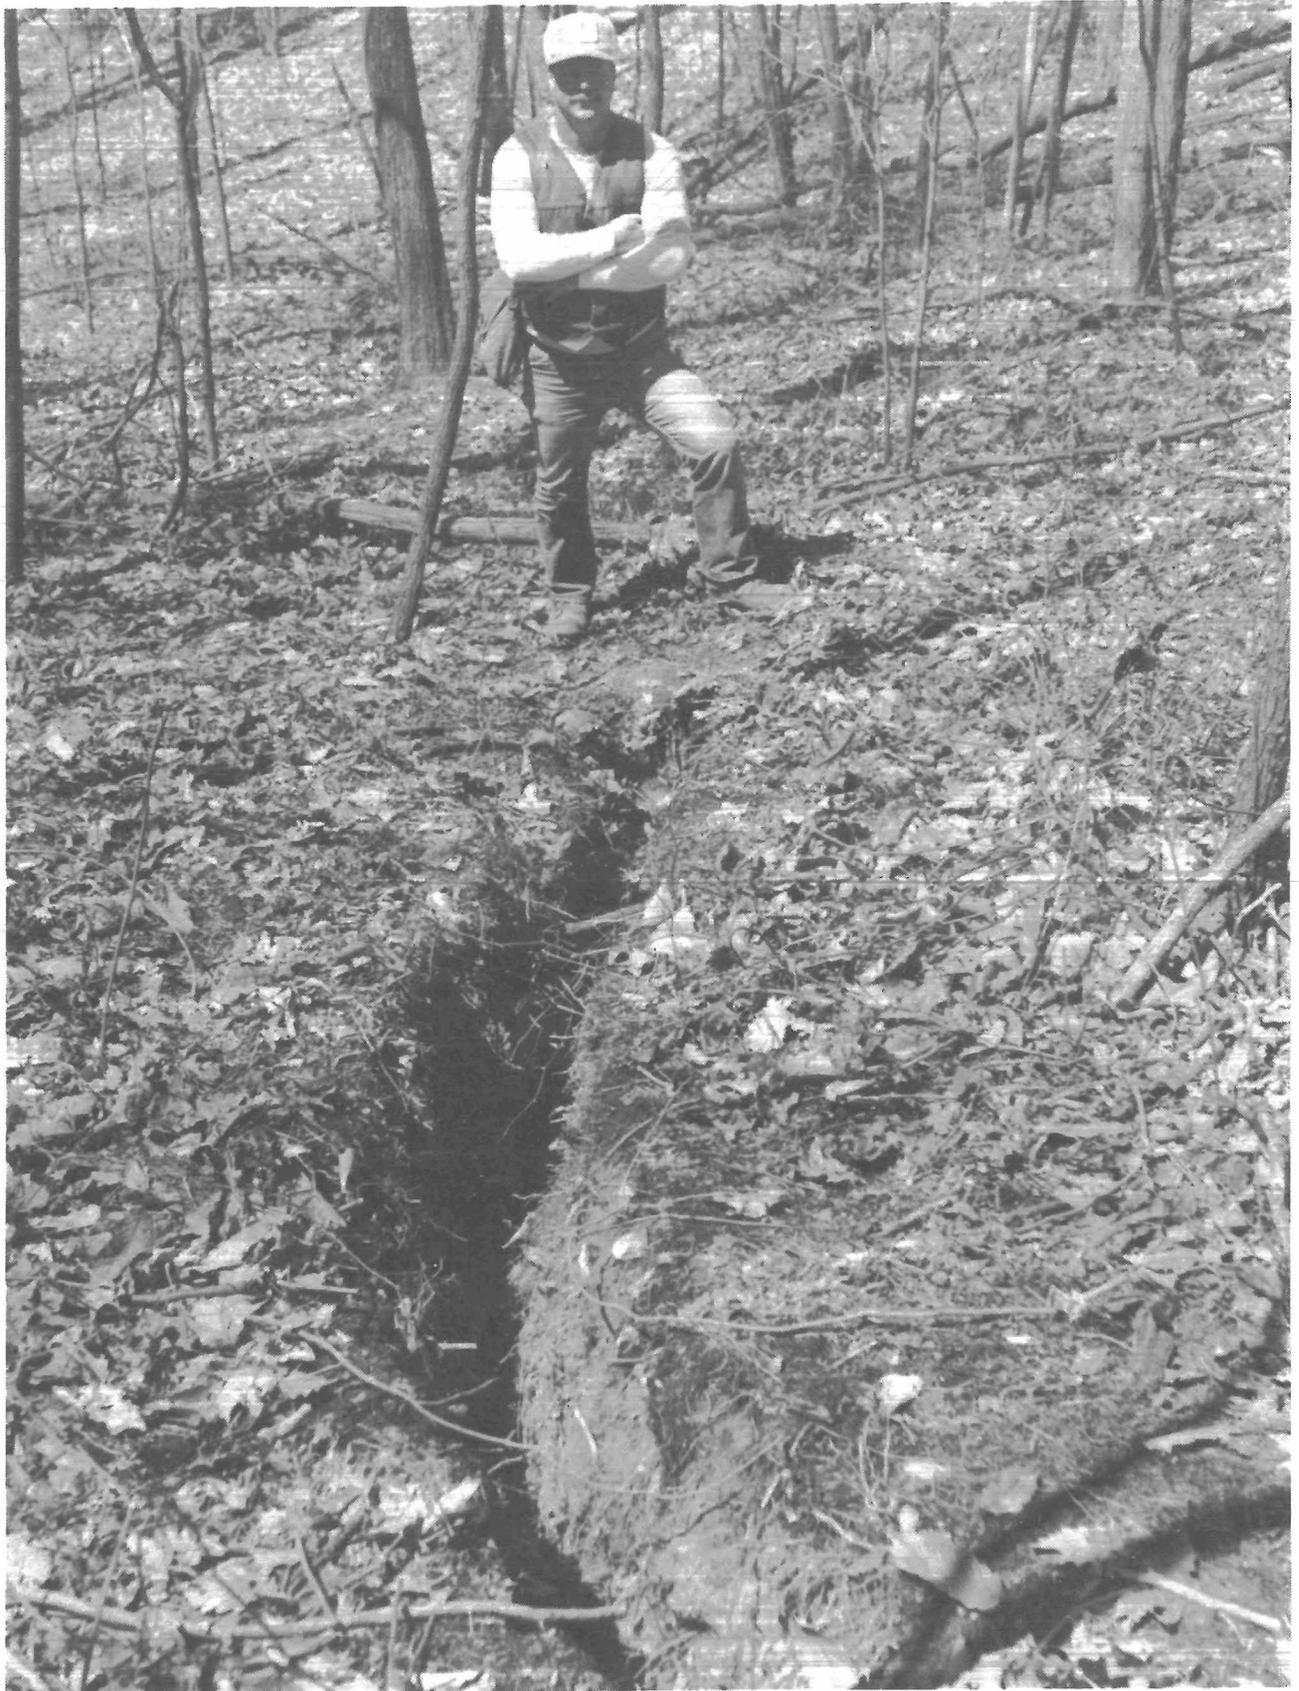
Orientation of the two parallel fractures ranged between N 50° W and N 65° W. Orientation of the single fracture was N 23° W, approximately perpendicular to the two parallel fractures. Only the fractures over the gate entries have open zones (fig. 10). The fracture in the center of panel 3 was only expressed on the surface by a narrow crack several inches wide and deep (fig. 11). The open zones in the two paralleling fractures randomly occurred along the fracture traces. These open zones were connected by a narrow crack only a few inches wide and deep. On the surface, these open zones ranged from about 0.5 to 2 ft in width and from 2 to 15 ft in length (fig. 10). In cross section these open zones were V-shaped. They narrowed in width as they increase in depth. Depth varied from 0.5 to 16 ft.

A vertical fracture or joint plane was observed in the bedrock in several of these open zones. The horizontal offset of these open zones suggests that there may be a series of adjacent parallel fractures instead of a single fracture plane. Stratigraphically, depth to bedrock varied from 0 to 8 ft. The only observed rock unit underlying the overburden was a sandstone. Total thickness of the strata between the fractures and the mine ranged from 1,000 to 1,100 ft. The three fractures have undergone subtle changes from when they were first identified.

Figure 10.-Open zone in a paralleling fracture overlying Mine B.

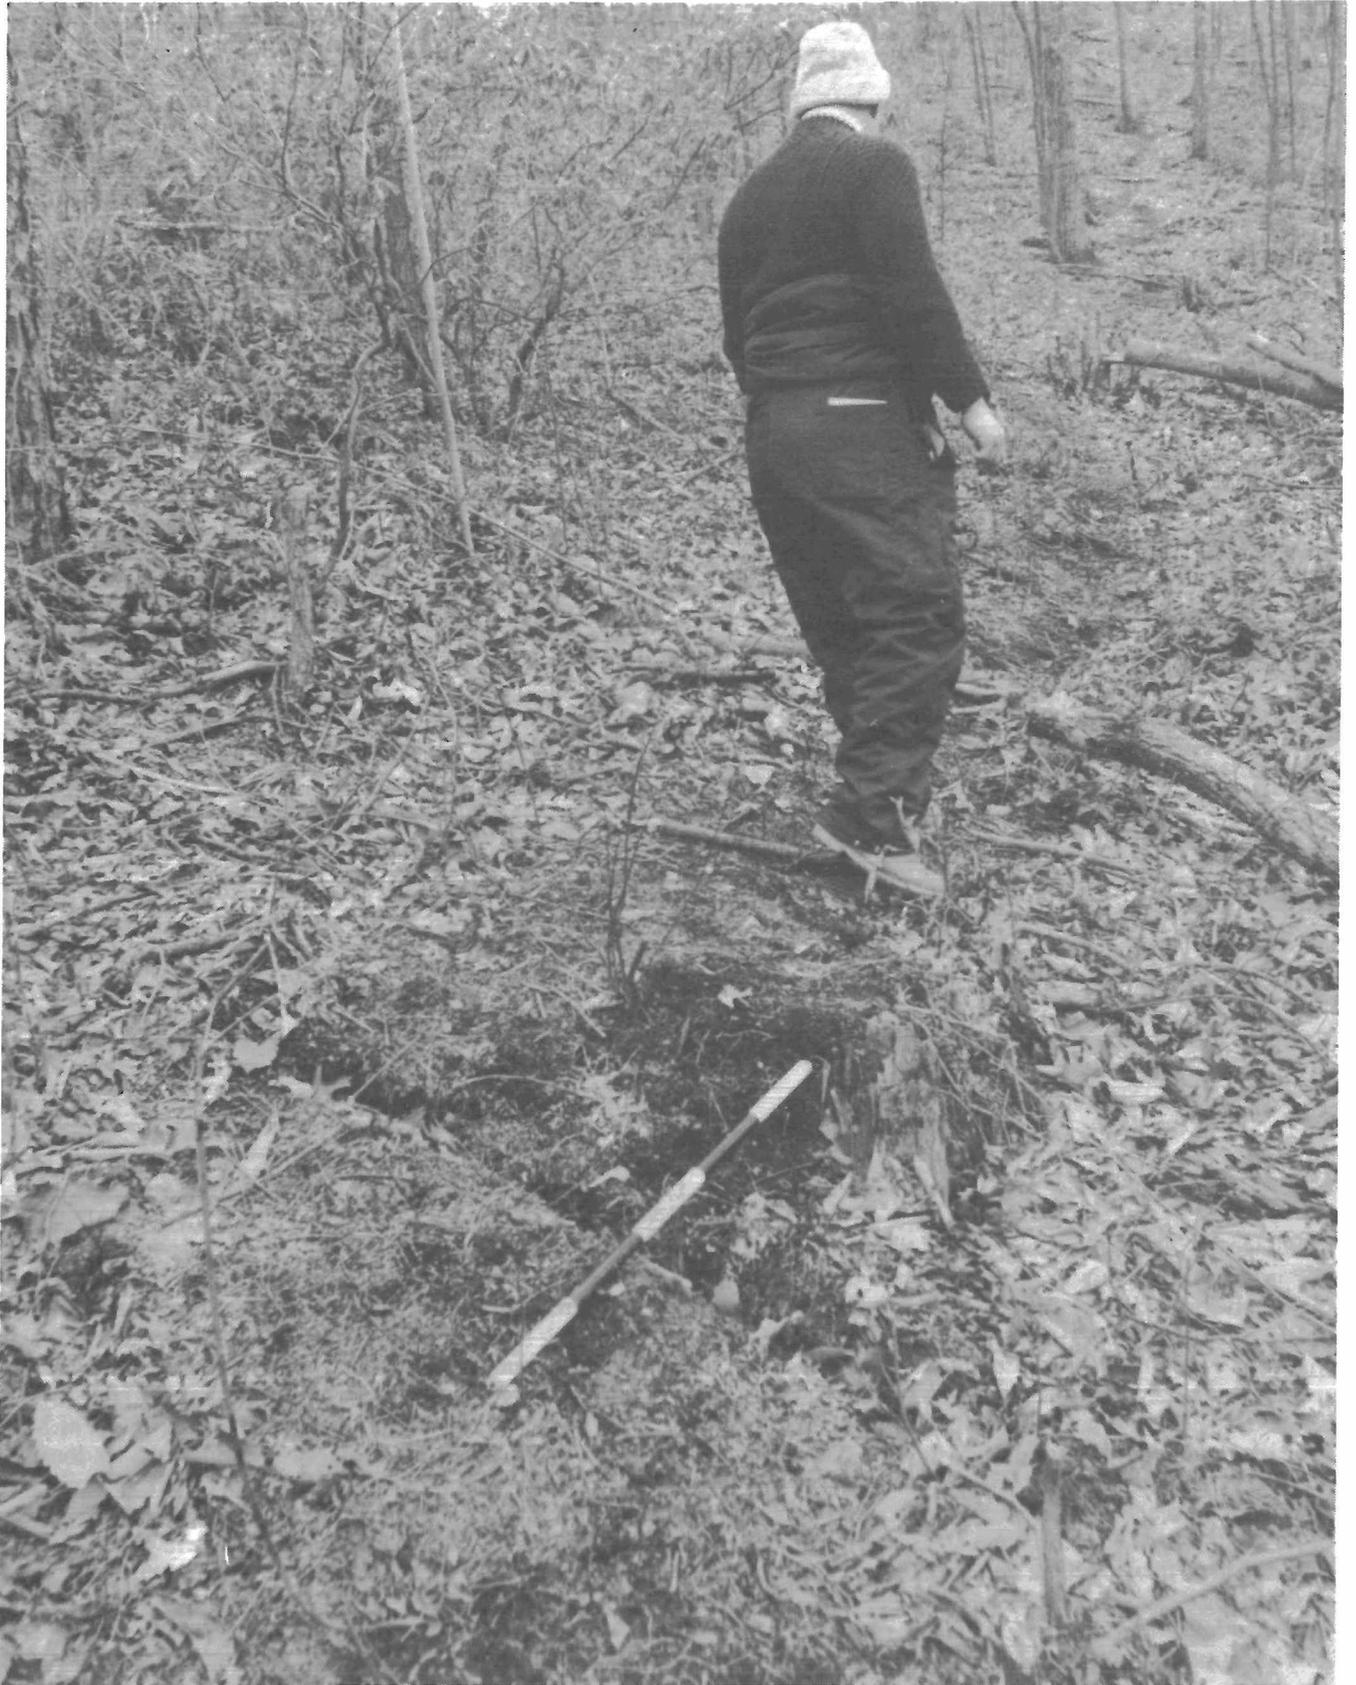
Figure 11.—Single hairline fracture overlying center of panel 3 at Mine B.

subsidence wave. The wave may have caused a tensional opening that was closed by the trailing compressional stress as the wave advanced. This would explain why just this fracture has no open zone along its trace.

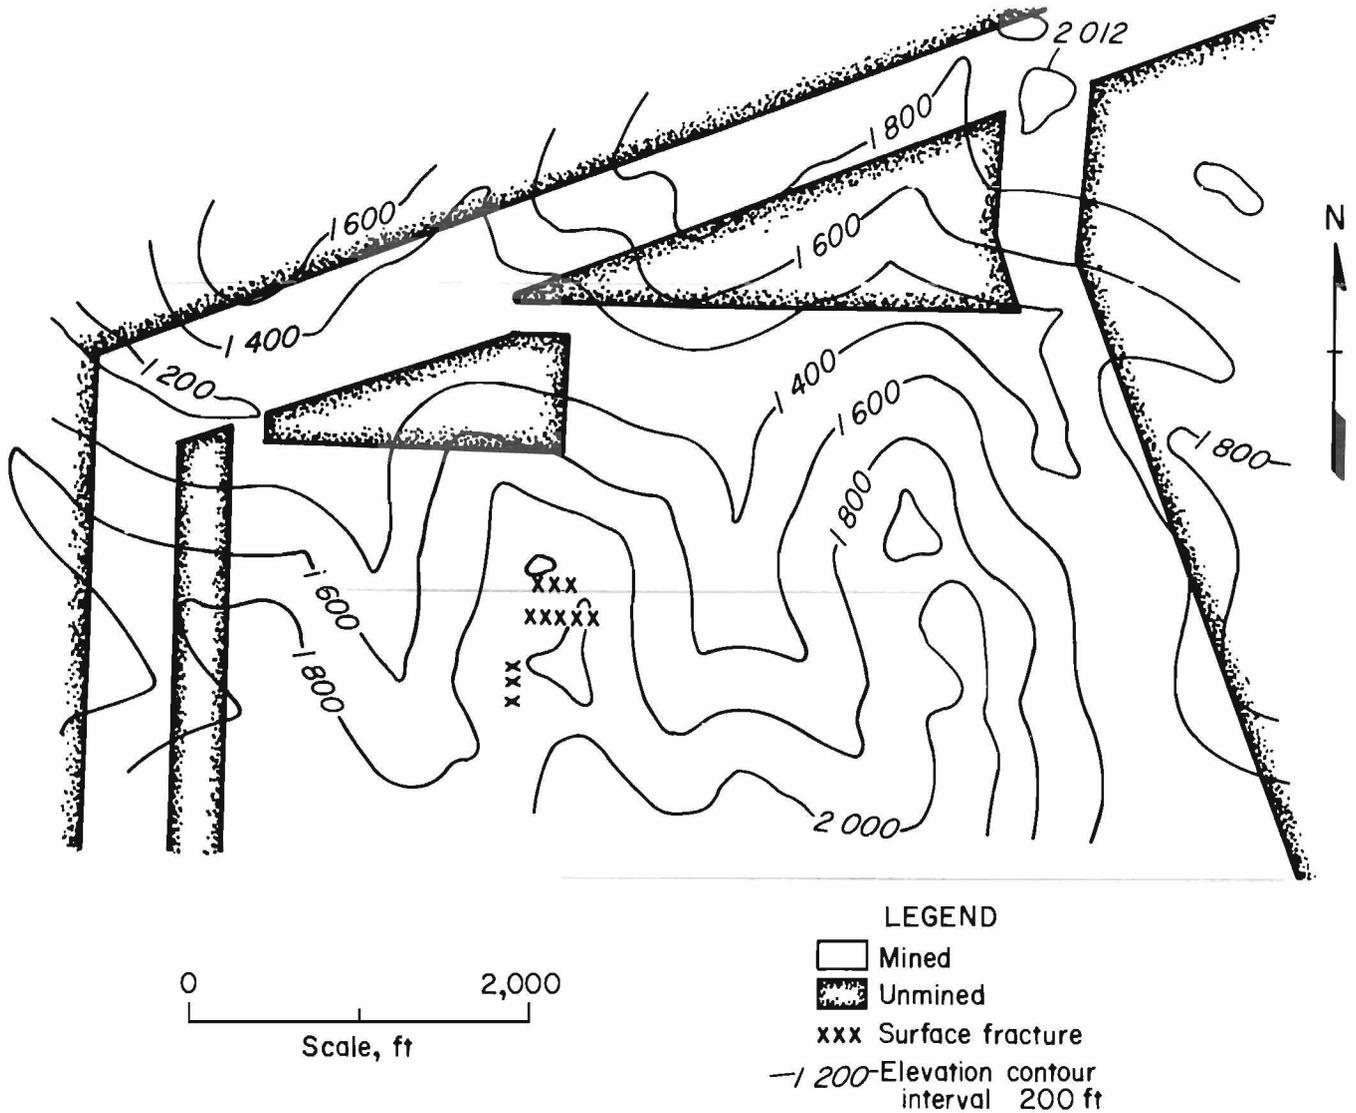
All three fractures were situated on or near the top of a mountain ridge (fig. 12). As at Mine A, these fractures do not parallel surface contour elevations. The two parallel fractures ranged in elevations from about 1,920 to 2,000 ft. The longest fracture extended over the top of the ridge and continued down both sides. The single fracture ranged in elevation from approximately 1,920 to 1,980 ft. Elevation at the top of the mountain ridge was about 2,000 ft. The relief in the study area was about 880 ft with slopes of 25°. To date there has been no strip mining in the study area of Mine B.

Figure 12.—Topographic map with locations of fractures overlying Mine B.

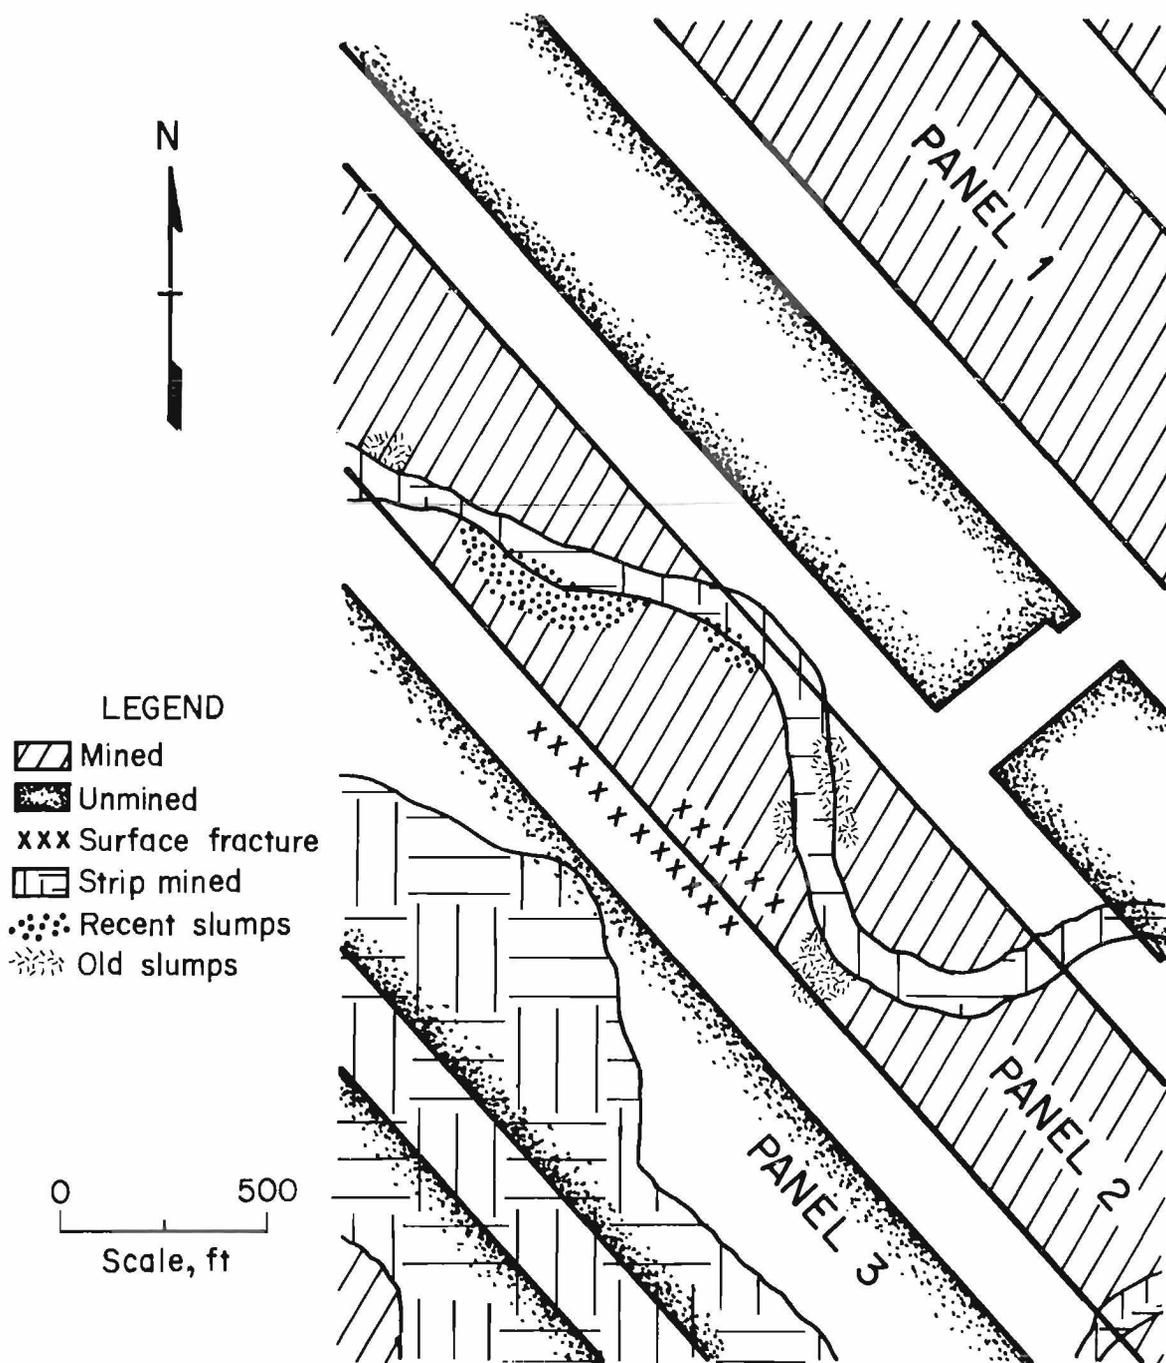
Surface slumping, evidence of a readjustment in the slope stability, was observed along the lower strip mine bench (fig. 13). Several of the slumps had characteristics of being recent. Trees were tilted and freshly exposed soil was observed within the slumps (fig. 14). The older slumps were distinguished from the more recent slumps by occurrence of mature vegetation and vertical trees. Evidence of recent slumping suggests that the fractures could have been influenced by this movement. Slumping may have contributed additional movement during or after the development of the fractures.

Figure 13.—Locations of fractures, strip mines, and slump features overlying Mine A.
